**Archaeological Monitoring  
the Demolition and Dismantling-  
Commemoration Project, Marshall Lime Kilns,  
Upper James and Red Hill Expressway,  
Regional Municipality of Hamilton, Ontario**

Submitted to  
**Regional Municipality of Hamilton-Wentworth  
Hamilton, Ontario**

**ARCHAEOLOGICAL SERVICES INC.**  
662 Bathurst Street  
Toronto, Ontario

December 1994

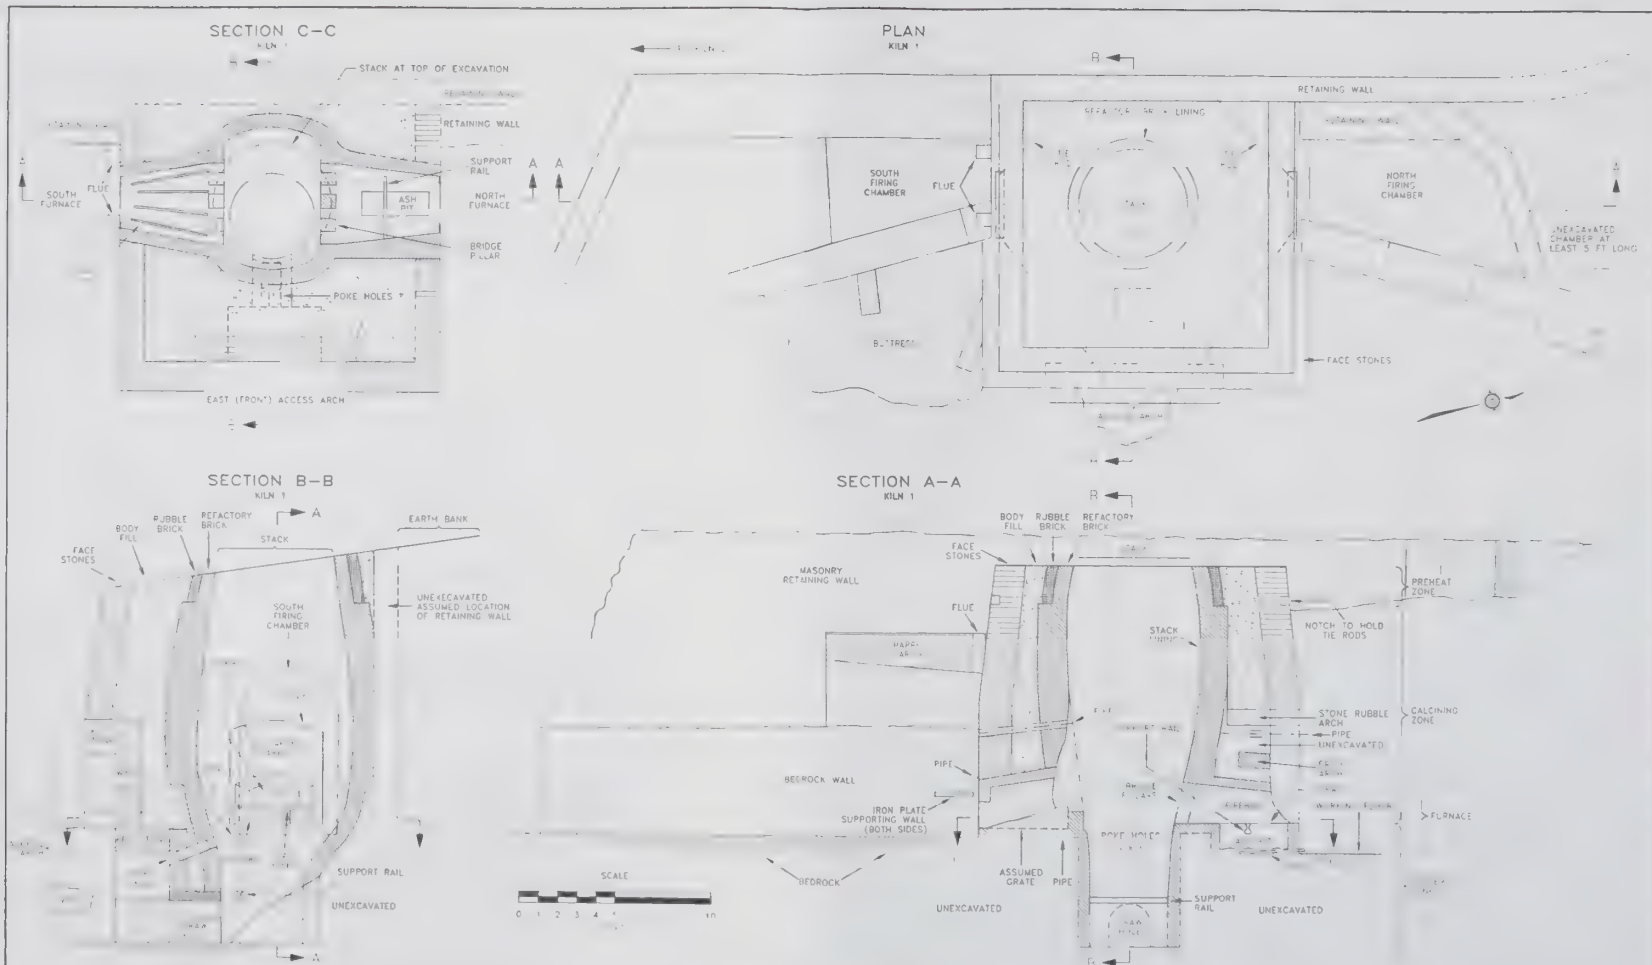
The blocks in the top two feet of the kiln were marked with what appears to be "WBS["S" is reversed]TEEL2". Elsewhere the bricks were marked "BUCKEYE". Some blocks had no visible marking.

In general, the bricks appear to be fire clay, although some were composed of material that resembles crushed brick or slag mixed with fire clay. The block that is marked "WBSTEEL" seems to be of this composite material while the "BUCKEYE" bricks seem to be of fire clay.

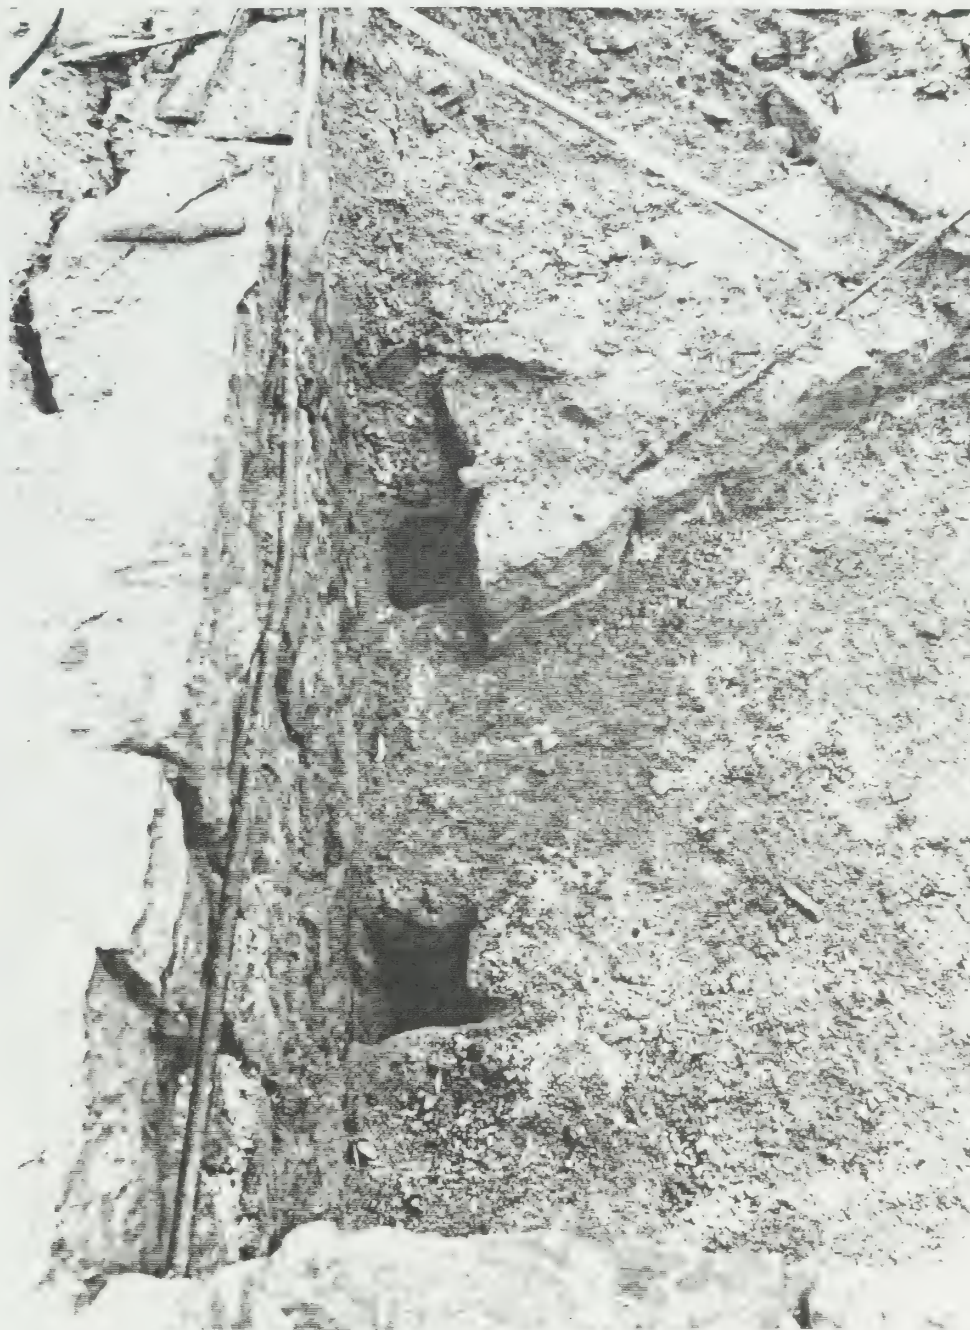
**Plate 16: Kiln One - South Furnace**

Flues on top of the south firing chamber, Nov. 20, 1991.

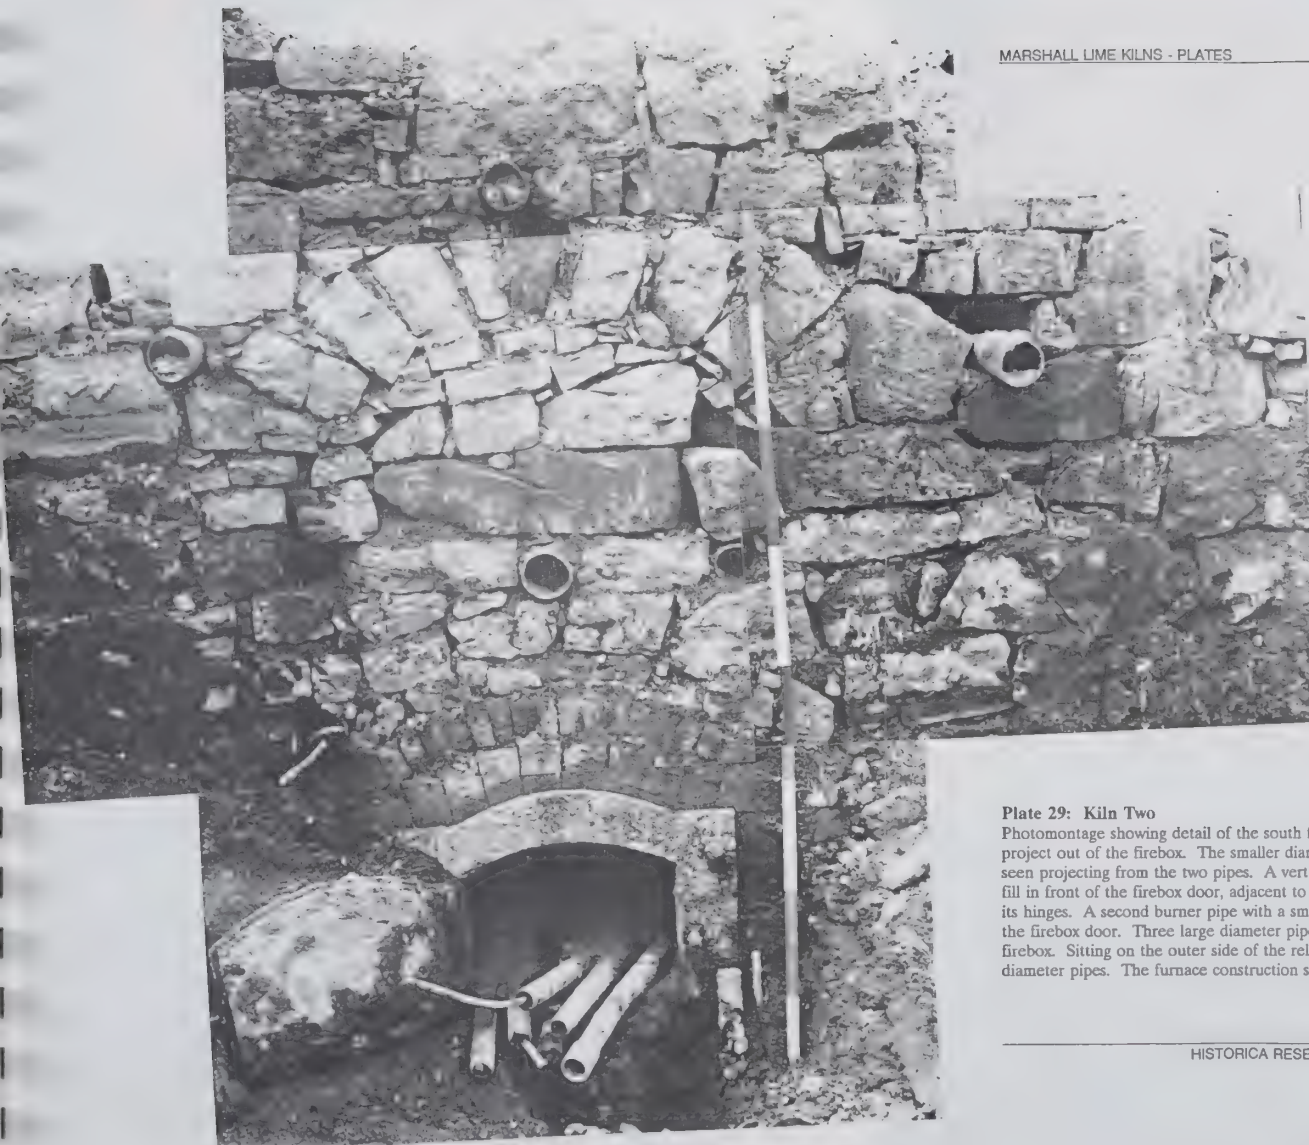
**Plate 29: Kiln Two**

Photomontage showing detail of the south furnace, July 11, 1994. Six burner pipes project out of the firebox. The smaller diameter inner (assumed) gas pipe can be seen projecting from the two pipes. A vertical pipe of unknown function rises out of fill in front of the firebox door, adjacent to the range rod. The firebox door is still on its hinges. A second burner pipe with a smaller diameter inner pipe is directly above the firebox door. Three large diameter pipes are also located directly above the firebox. Sitting on the outer side of the relieving and are an additional three, large diameter pipes. The furnace construction seems to be similar to Kiln One [Plate 15].

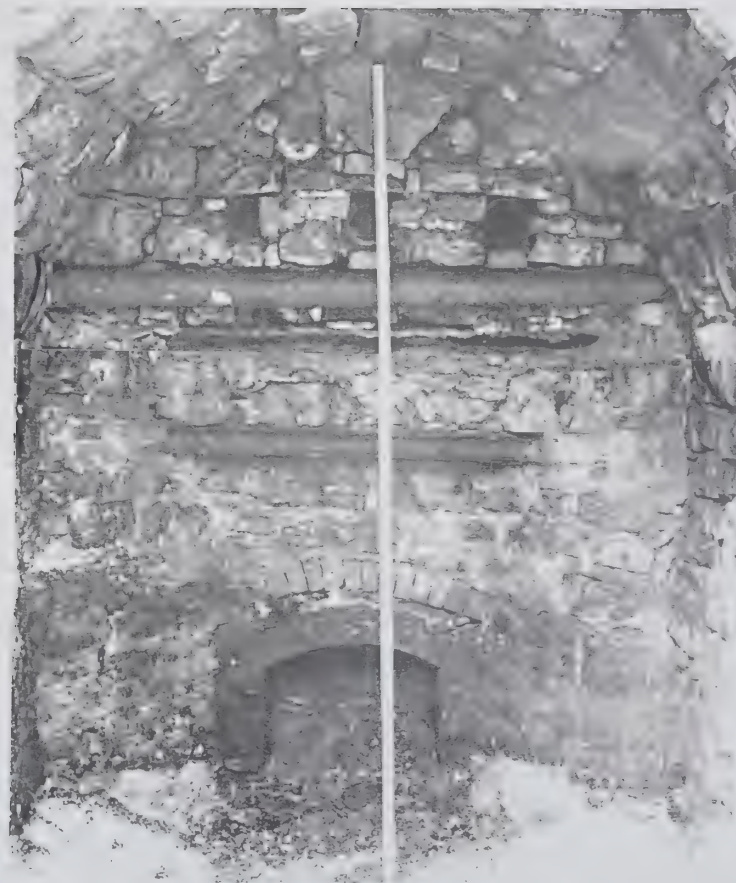
**Plate 31: Kiln Two**

Photomontage of the end of the access arch at the kiln wall, showing the poke holes at the top, two metal pipes of unknown function extending horizontally, the upper one of which is almost intact, the lower one having rusted through, July 12, 1994. In centre of the photo is a section of the railway rail, presumably used for structural purposes. The draw hole is at the bottom.

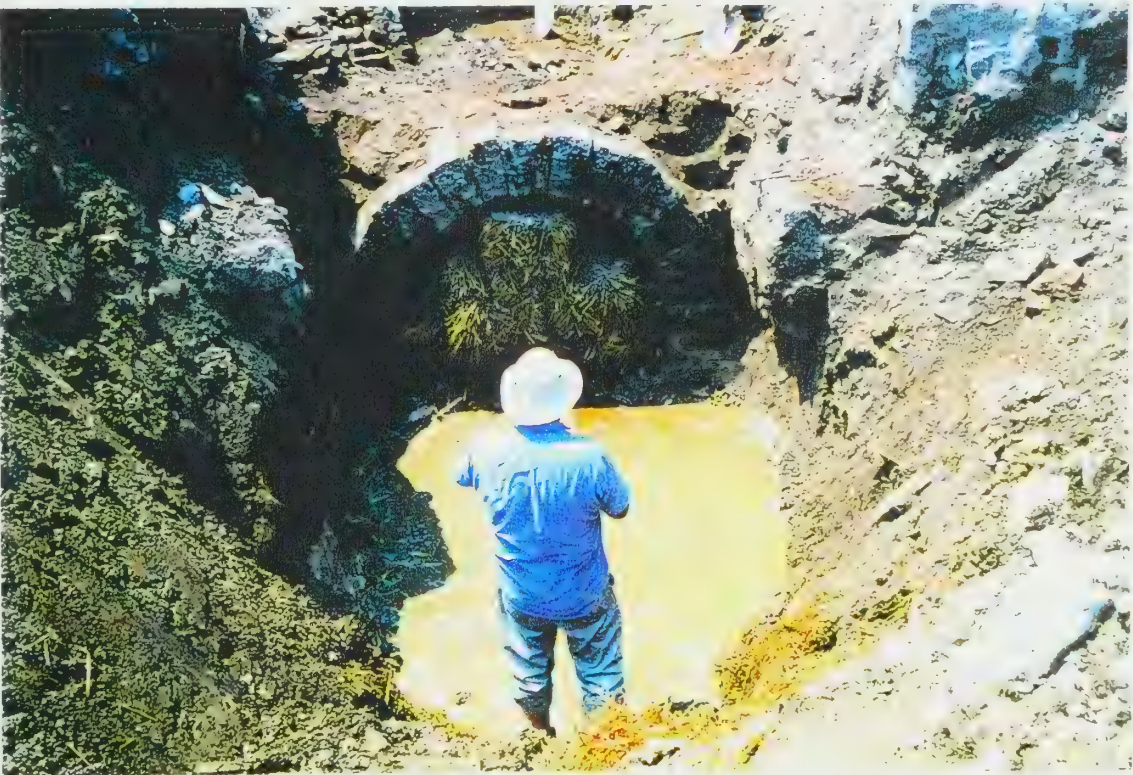
Plate 8: Flooding.

The lower level of the kiln was quite damp and cool. The temperature gradient between the kiln and the air was such that condensation instantly appeared on the surface of the Mylar<sup>tm</sup> when trying to trace the area below the small arch. This made recording in this area quite difficult. Condensate would form as quickly as one could wipe it off. In addition to this, a large rainfall midweek flooded out the area (Plate 8). The site was pumped out on several occasions but to

no avail. The bales of straw used to support the arches proved to be useful sponges absorbing considerable amounts of water. The flooding slowed the work and made it more treacherous.
